CABIN JOHN CREEK

WATERSHED STUDY

**Montgomery County
Department of Environmental Protection
Watershed Management Division**

June 9, 1999

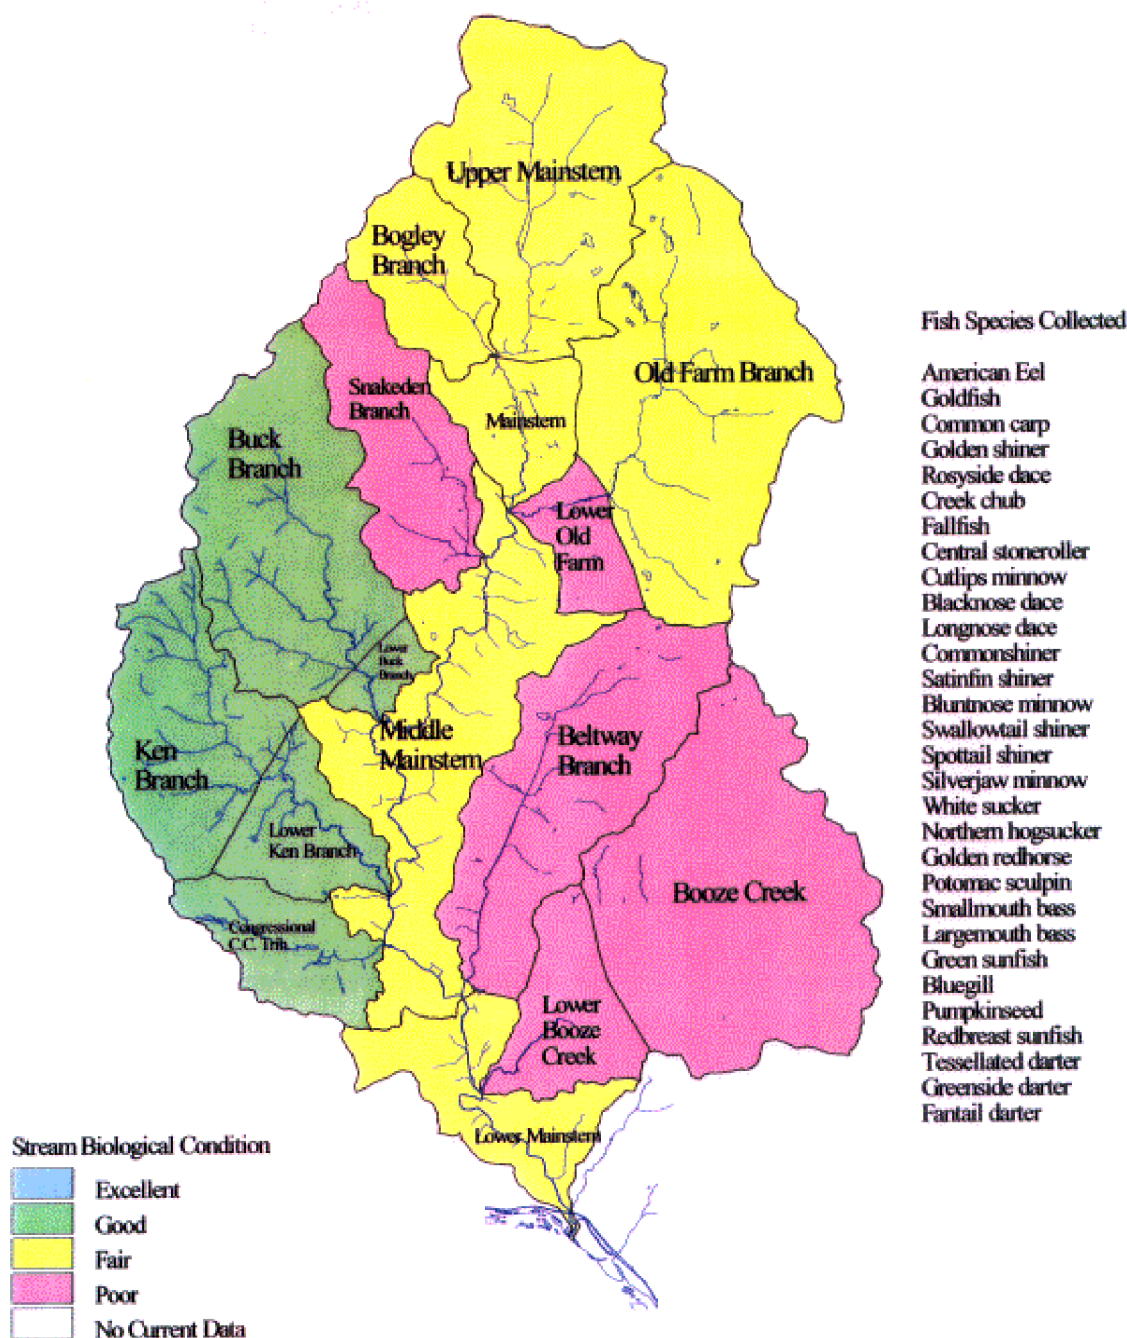
Figure 2. Stream Condition Map of Cabin John Creek.

CJCJ307) received a resource condition score of *fair* (Figure 2). Interim biological index scores for benthic macroinvertebrates were generally lower than fish index scores. Qualitative habitat condition was rated as *good* in the upper and lower sections. The habitat in the middle section of Cabin John was rated as *fair*.

Two western tributaries Buck Branch (CJBB201) and Ken Branch (CJKB201) received an overall resource condition rating of *good* (Figure 2). The qualitative habitat condition of Buck Branch was on the margin between *good* and *fair* overall. Ken Branch habitat condition was rated as *fair*.

The Snakeden Branch (CJSB101), Thomas Branch (CJTB101a and CJTB101b), and Booze Creek (CJBC202) tributaries received an overall resource condition rating of *poor* (Figure 2). The qualitative habitat conditions at each of these tributaries was rated as *fair*.

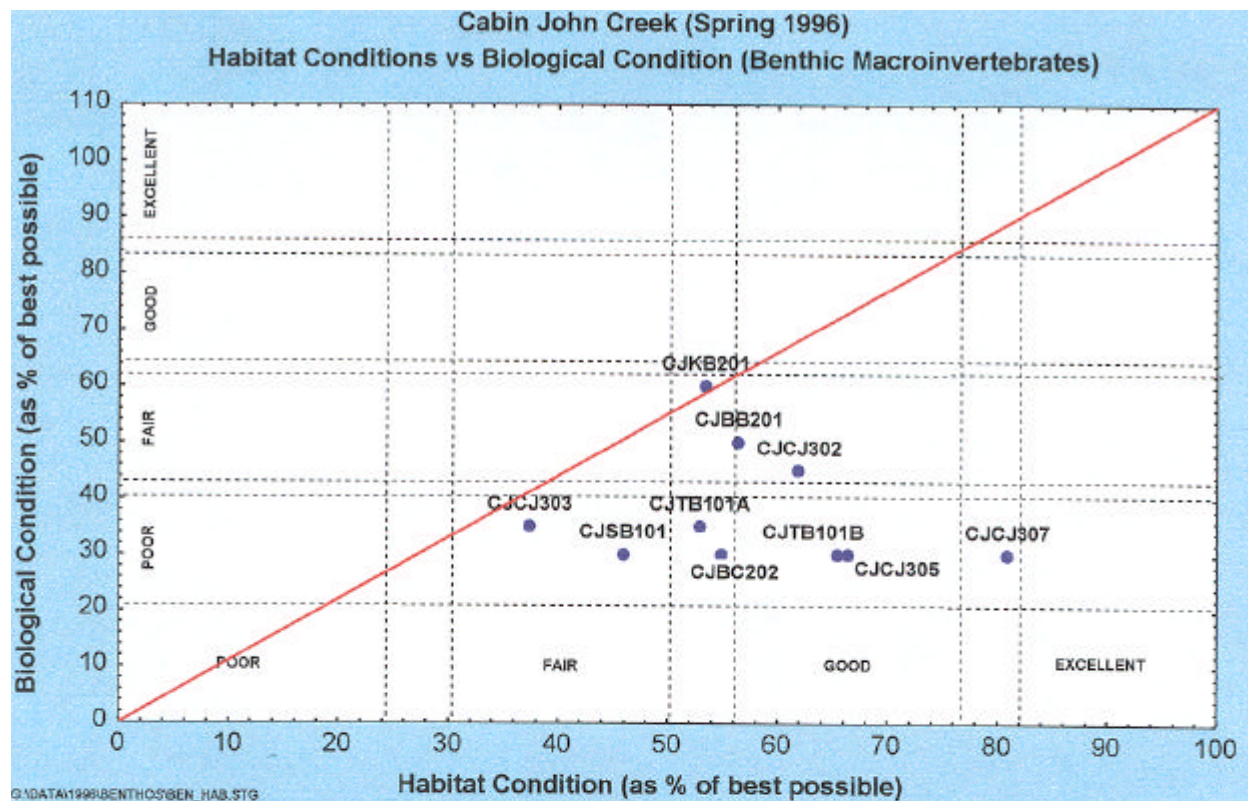
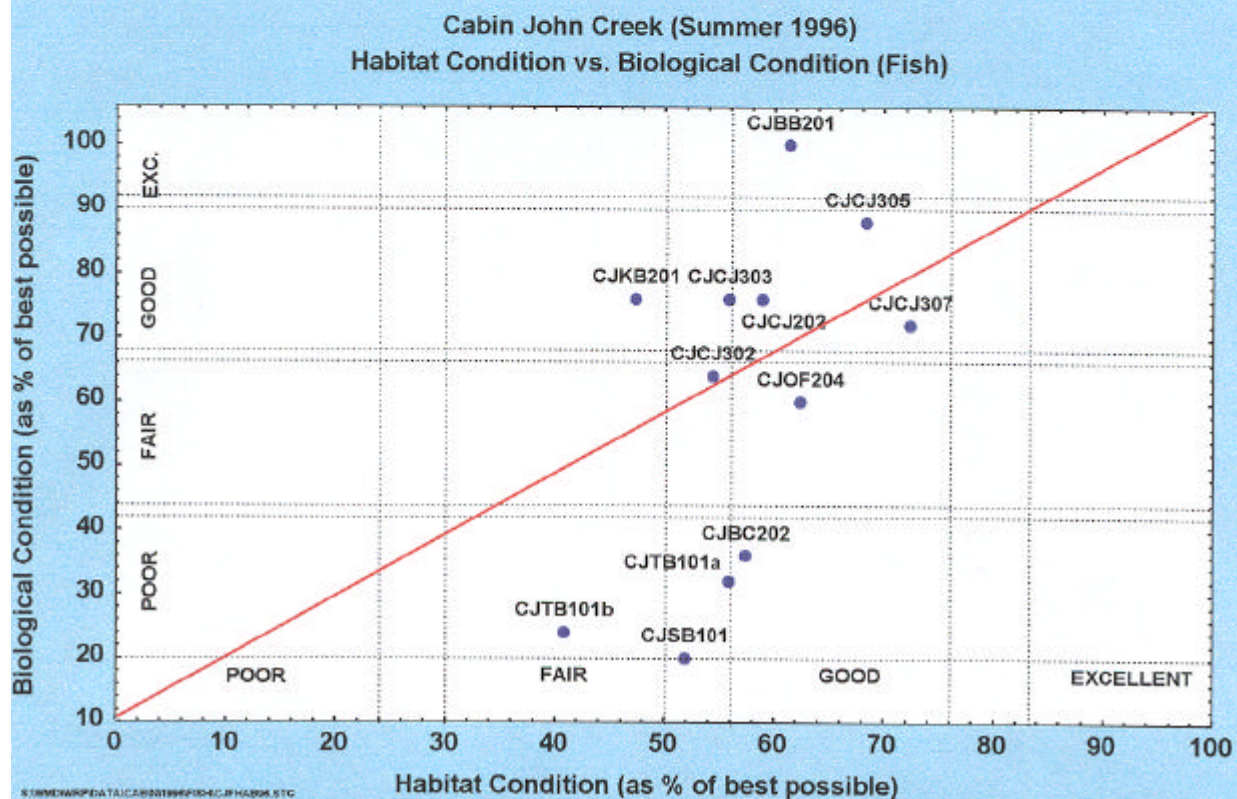
Figure 3. Identification of Possible Causes of Stream Impairment Using Habitat vs Biological Condition Relationships.

The benthic macroinvertebrate community IBI scores were either *fair* to *poor* throughout the watershed indicating an impaired benthic macroinvertebrate community. Stations CJCJ303, CJSB101, CJCJ302, CJBB201, and CJKB201 plot closely to the expected biological condition/habitat condition regression line (Figure 3). For these stations, the likely cause of impairment to the biological community is the current habitat condition.

Stations CJTB101a, CJBC202, CJTB101b, CJCJ305, and CJCJ307 deviate from the expected biological condition/habitat condition regression line and cluster in an area of the graph which reflects good to excellent habitat conditions but poor to fair IBI scores (Figure 3). These stream reaches should have a better benthic macroinvertebrate community because the habitat condition indicates support for good to excellent biological integrity. Evaluation of the individual parameters used for the qualitative habitat assessments further indicate that there are observed problems with embeddedness, sediment deposition, and bank stability. Uncontrolled runoff at the older developments have probably contributed to the current sediment erosion and deposition problems occurring within the stream channel. Heavy winter rains producing flood events that resulted in erosive flows during the winter/spring of 1996 (USGS 1996) may also

The fish community IBI scores ranged between the excellent to poor IBI classes (Figure 3). All but five station scores plot very close to the expected IBI/habitat regression line (Figure 3). Stations CJSB101, CJBC202, CJTB101a, and CJBB201 deviate from the expected IBI/habitat regression line and cluster in areas of the graph which reflects either good to excellent habitat conditions with poor to fair IBI scores (stations CJSB101, CJBC202, CJTB101a), or fall in areas of the graph with lower habitat scores than would be expected with the very high IBI score (CJBB201) (Figure 3). Stations CJSB101, CJBC202, CJTB101a should have a better fish community because the habitat condition indicates support for good to excellent biological integrity. Evaluation of the individual parameters used for the qualitative habitat assessments indicate that there were observed problems with embeddedness, sediment deposition, and bank stability even though the overall habitat assessment was scored as either good or excellent.. Uncontrolled runoff at the older developments have probably contributed to the current sediment erosion and deposition problems occurring within the stream.

Station CJBB201 supports a somewhat higher fish community (IBI = excellent) than the habitat alone (habitat score = good) would indicate (Figure 3). Nutrient enrichment may be present in this subwatershed of Cabin John. Elevated nutrients could be supporting a higher number of tolerant benthic macroinvertebrates than habitat alone would support. In turn, the insectivorous constituent of the fish community would be maintained by the more abundant benthic macroinvertebrates and the fish IBI score would reflect this condition. However, this condition could also be caused if the aquatic habitat was only recently impaired, and the fish and benthic communities were still reflecting the previous high quality habitat conditions. The later is doubtful because examination of the spring benthic macroinvertebrate habitat to IBI relationship (Figure 3) shows that the habitat of station CJBB201 was assessed as good while the benthic IBI score was also assessed as good. No recent habitat impairment is evident. Followup water chemistry monitoring will be conducted at this station during 1998. A base flow grab sample will be taken during mid-May to check for any elevated nutrient loads.

Stations that demonstrate possible impairment in both the spring benthic macroinvertebrate community and the fish community indicate areas of impairment from other than habitat stressors that are not of a seasonal or temporary nature. These area will need to have follow up field work to investigate likely causes of impairment and to initiate corrective actions when causes are identified. Areas in Cabin John that meet this criteria include Upper Thomas Branch (CJTB101a), Bucks Branch (CJBB201), and Upper Booze Creek (CJBC202) (Figure 3).

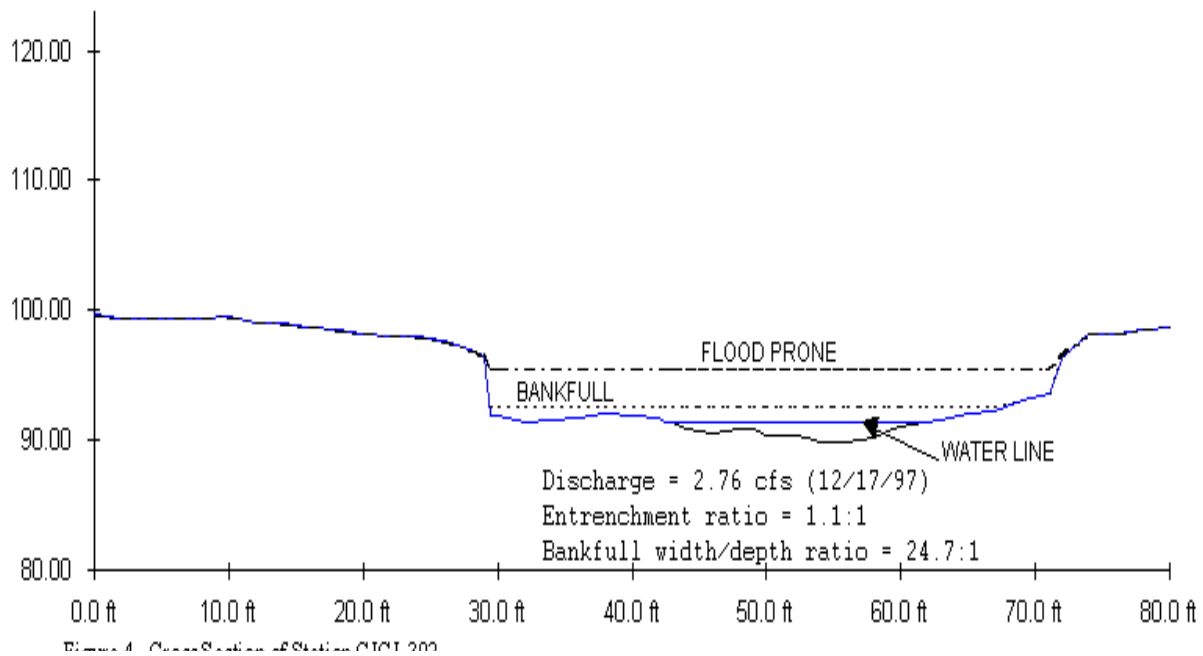
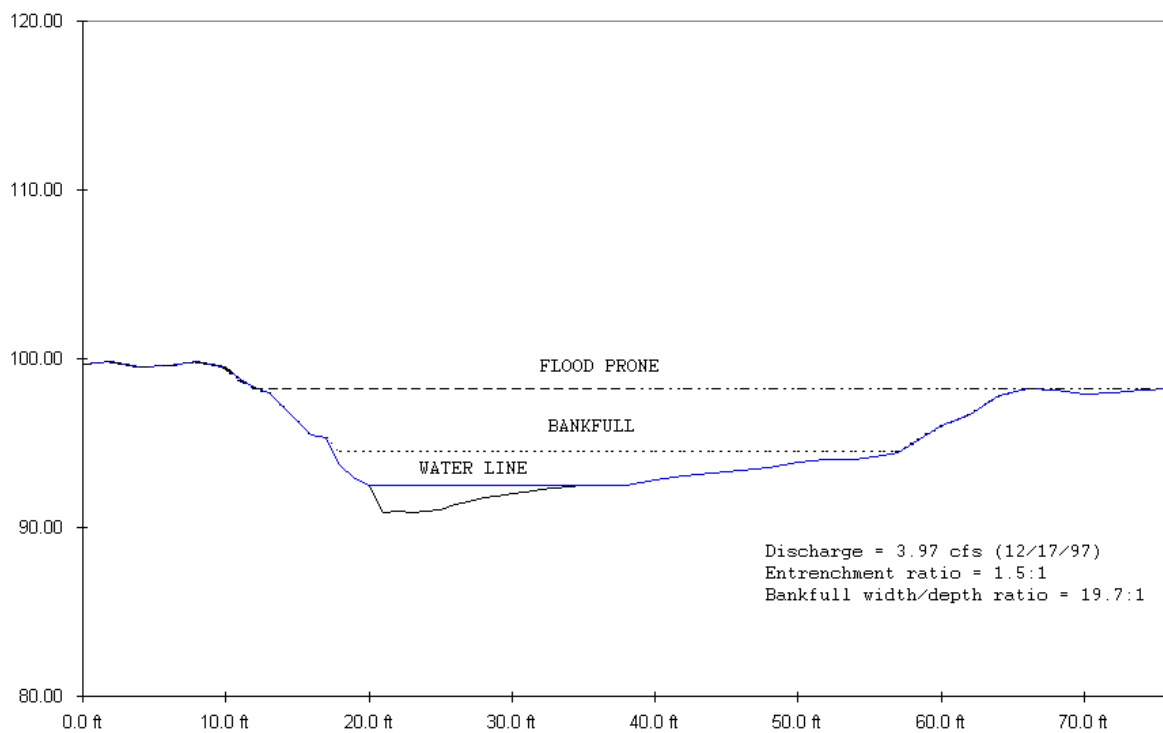
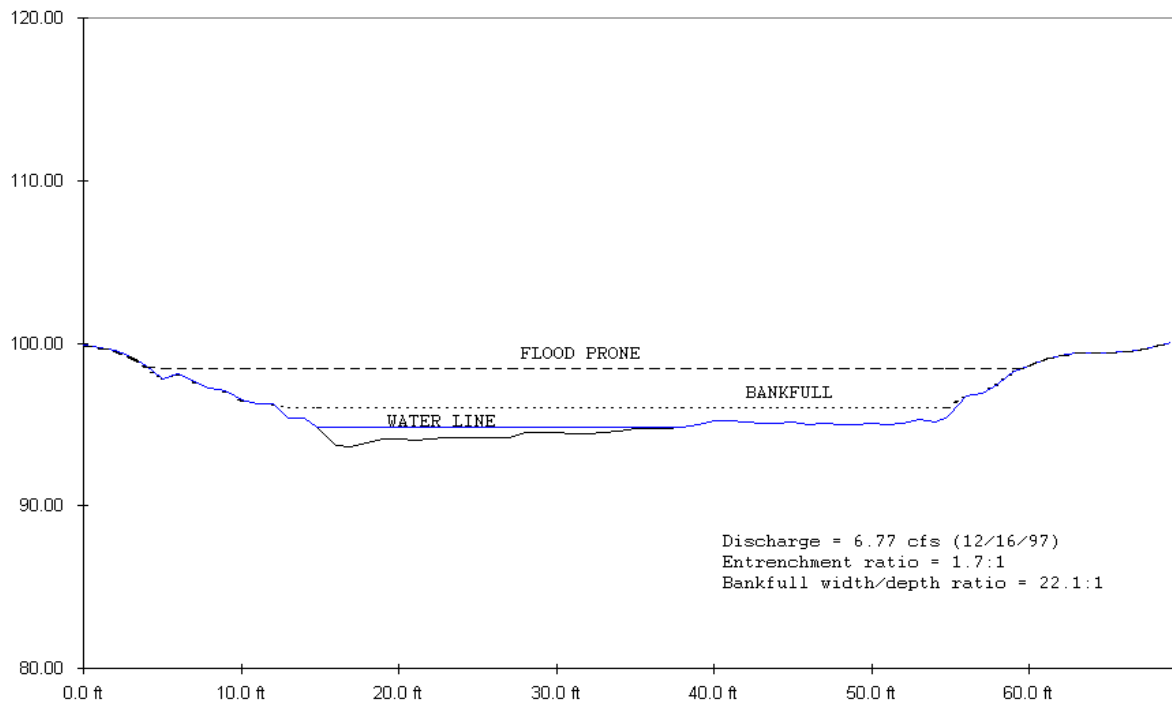
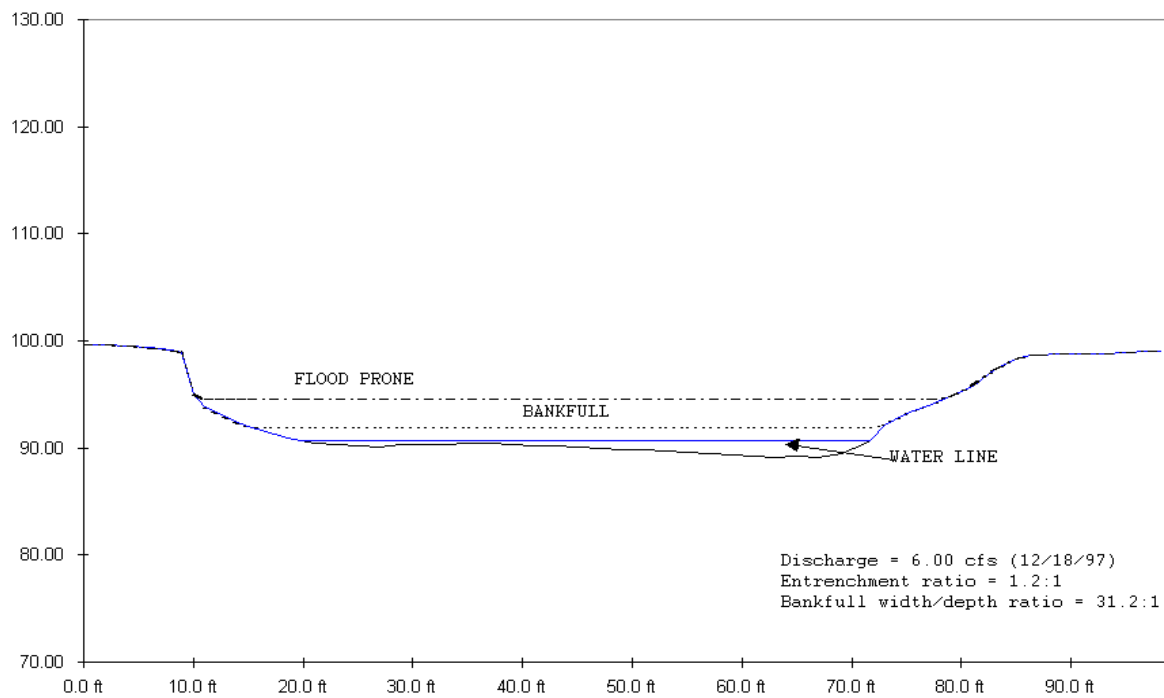
Figure 7. Cross Section of Station CJ-307.

Surveys conducted on the mainstem (CJCJ302, CJCJ303, CJCJ305, and CJCJ307) indicate an incised and widened stream channel with entrenchment ratios ranging from 1.1:1 to 1.7:1 (Figure 4 to 7). The term “entrenchment ratio” is the ratio of the width of the flood-prone area to the surface width of the bankfull channel, and expresses the vertical containment of a stream (Rosgen, 1996). The flood prone area is defined as the active floodplain and the first terrace level. These entrenchment ratios are indicative of a severely to moderately entrenched stream channel. This stream system does not currently have flood prone areas that are associated with relatively frequent storm events. This means that floods of up to the 50 year expected frequency flood are contained in the stream channel instead of dissipating energy over the floodprone area. Erosive velocities are directed against the stream banks with resulting high levels of bank erosion and sedimentation (Rosgen, 1996).

Width/depth ratios in the mainstem Cabin John range from 22:1 to 31:1. These ratios indicate an overly widened channel. These widened and entrenched stream channel areas are highly likely to be experiencing the accelerated bank erosion and sedimentation problems outlined above.

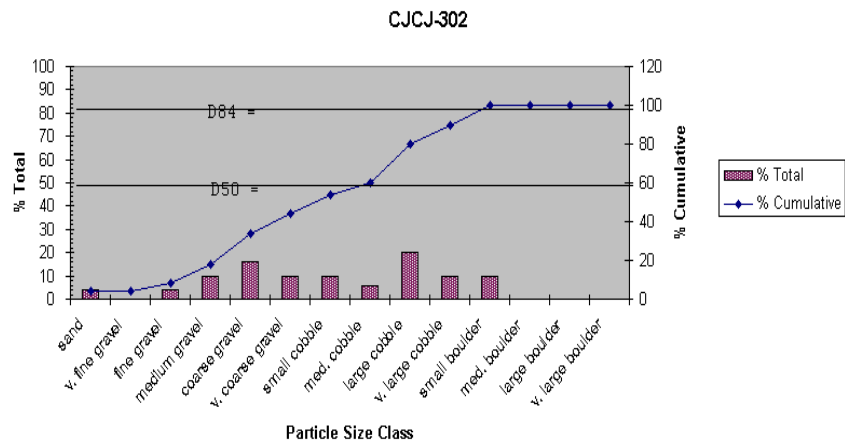
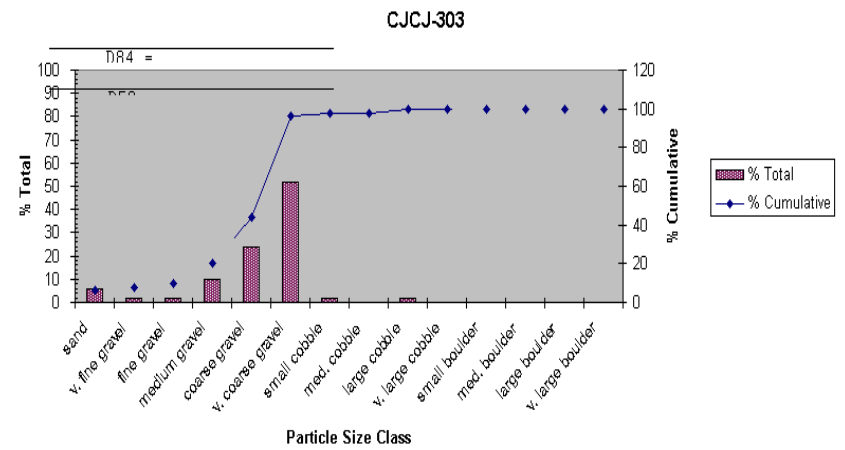
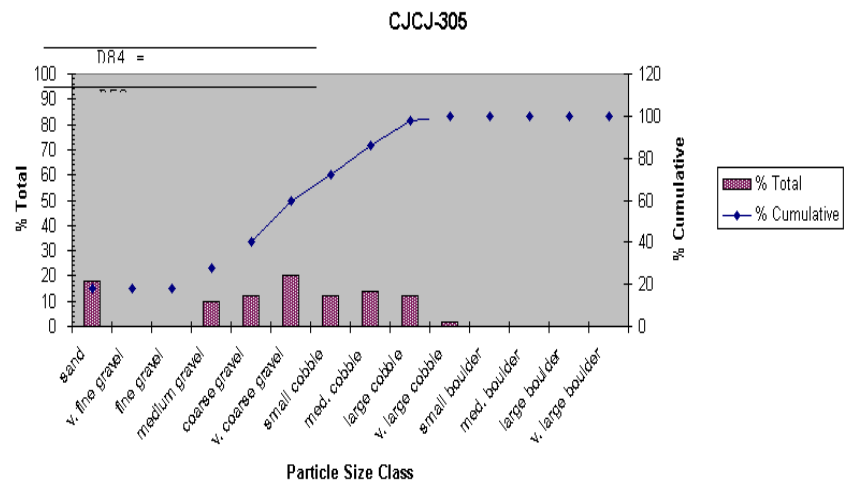
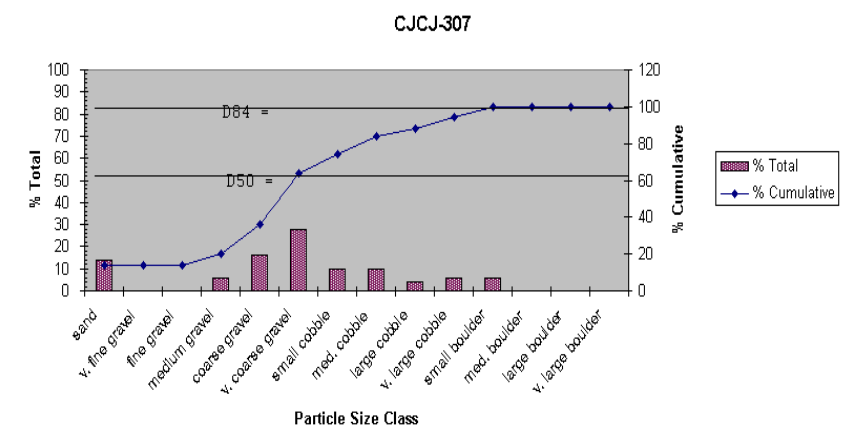
Figure 8. Riffle Particle Size Distribution for the Cabin John Watershed Main Stem Monitoring Stations, 1996.

Pebble counts taken from the riffle bottom substrate ranged from a D_{50} of coarse gravel to small cobble for riffle substrate in the mainstem (Figure 8). The D_{50} expresses the size particle that 50% of the riffle substrate falls under. In other words, 50% of the riffle particles measure in the coarse gravel to small cobble size or less. Although this particle size is not ideal, it is large enough to sustain a benthic community. The average embeddedness estimates of these riffles is 65%. This moderate embeddedness level is enough to impair the resident benthic communities. Embeddedness is a measure of how much fine sediment surrounds the larger rocks of riffles and runs. If embeddedness levels are too high (>50%), the fine sediments can severely impact the available riffle habitat for benthic macroinvertebrates and fish.

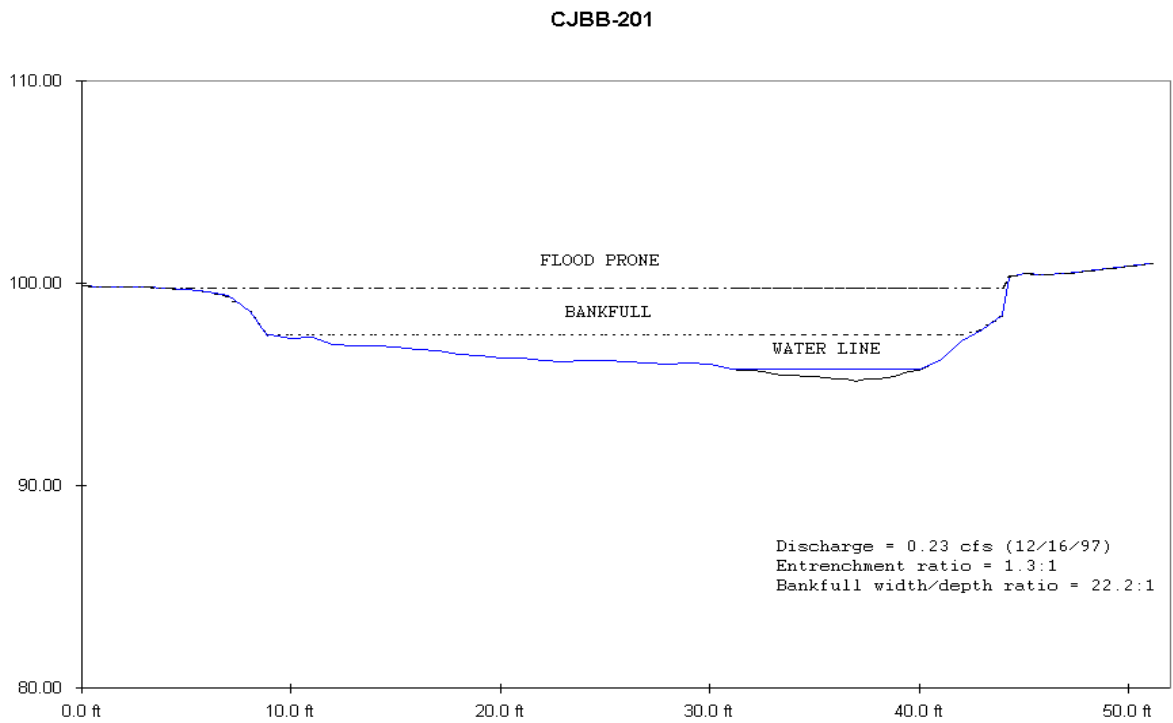
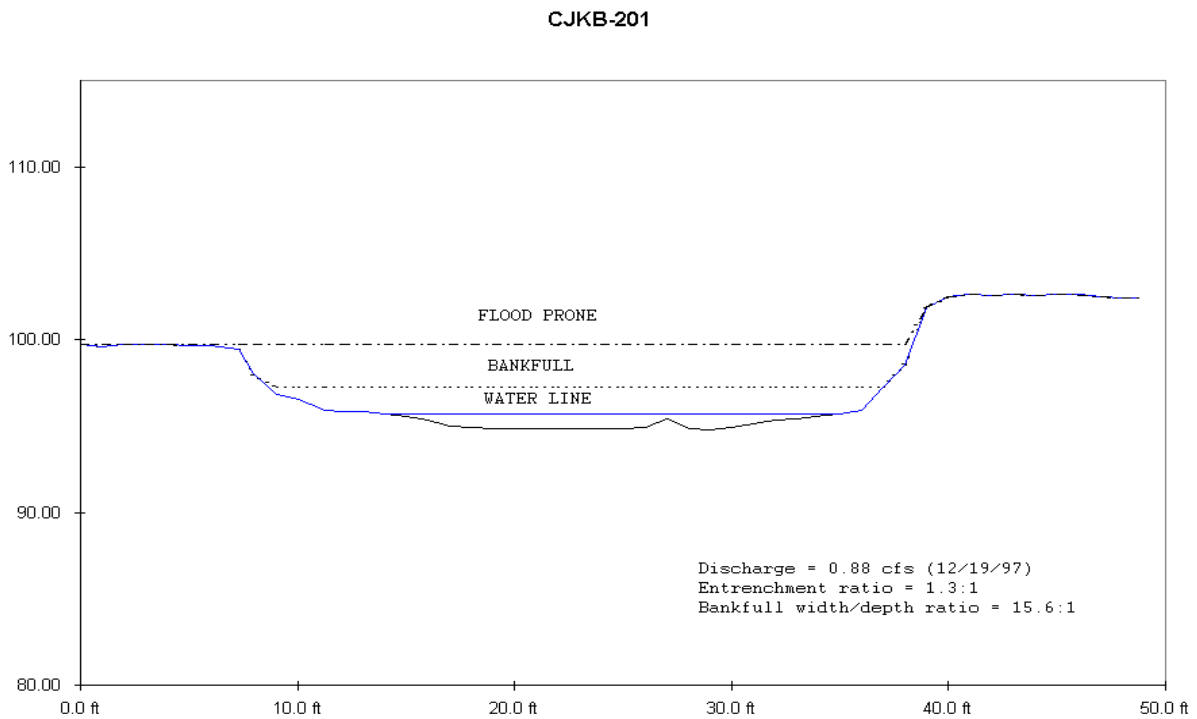
Figure 9. Cross Sections of Buck Branch and Ken Branch Monitoring Stations, 1996.

tributary (Figure 9). The entrenchment ratio of 1.3 indicates a severely entrenched stream channel. Width/depth ratios of 22 at Buck Branch (CJBB201) and 16 at Ken Branch (CJKB201) indicates an overly widened channel. These tributary channels indicate the same problems of accelerated bank erosion and sedimentation as the main stem stations.

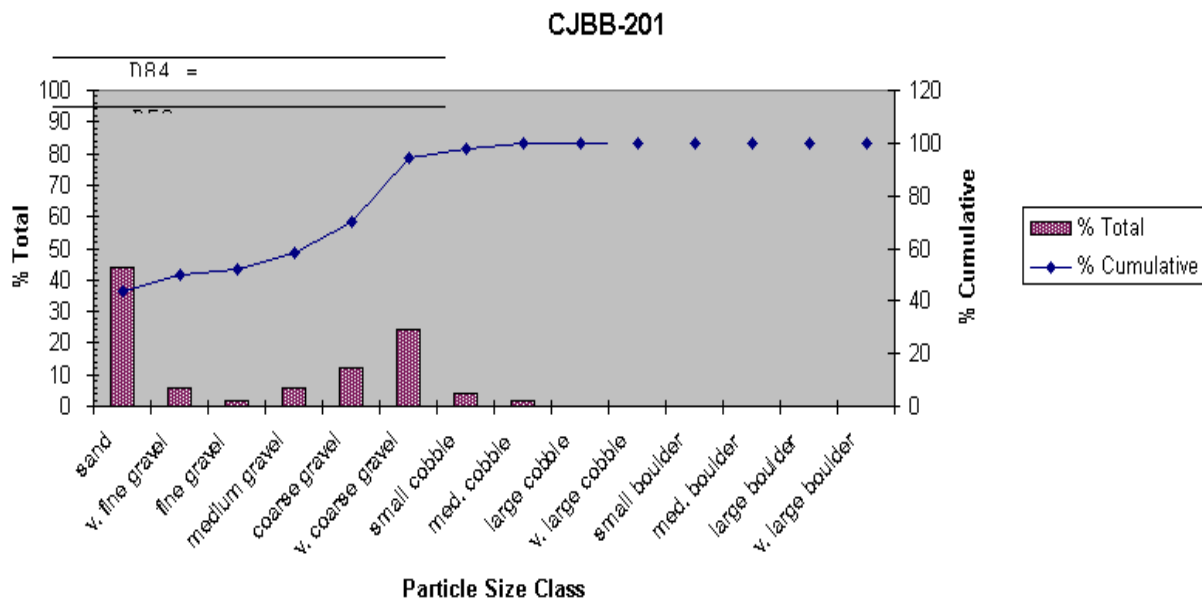
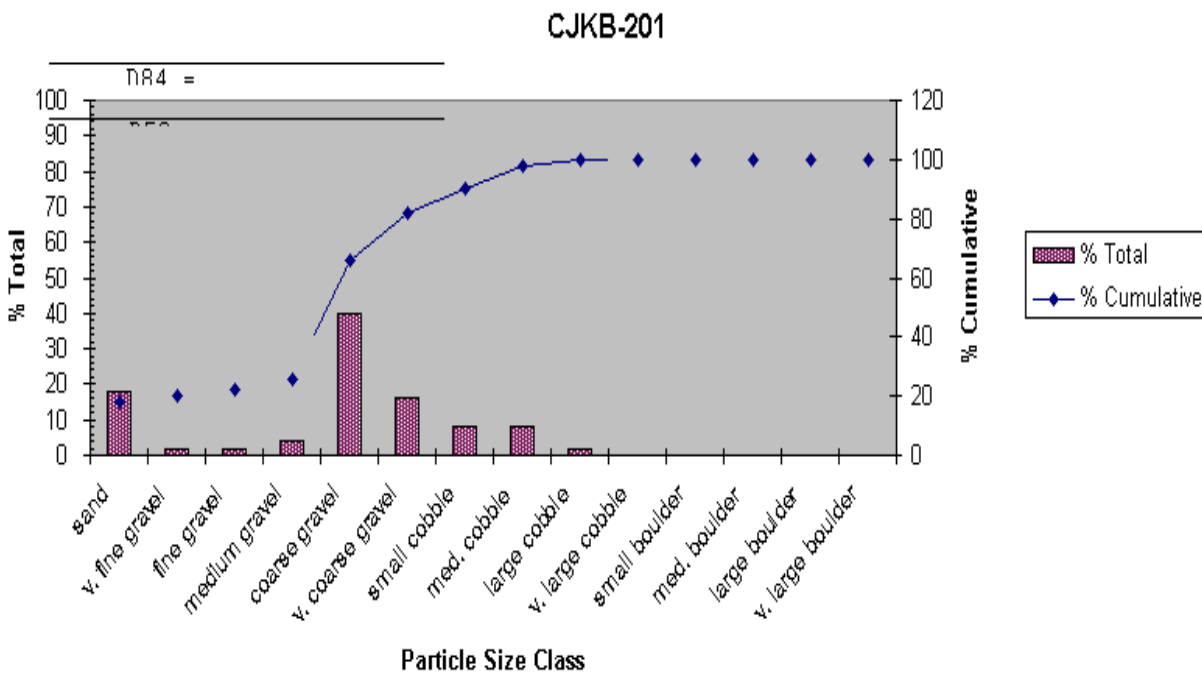
Figure 10. Riffle Particle Size Distributions for the Buck Branch and Ken Branch Monitoring Stations, 1996.

The pebble counts resulted a D_{50} of very fine gravel at Buck Branch (CJBB201) and coarse gravel Ken Branch (CJKB201) (Figure 10). The particle sizes in the riffle substrate in Buck Branch provide limited habitat for benthic macroinvertebrates. Particle sizes are a little less limiting at Ken Branch.

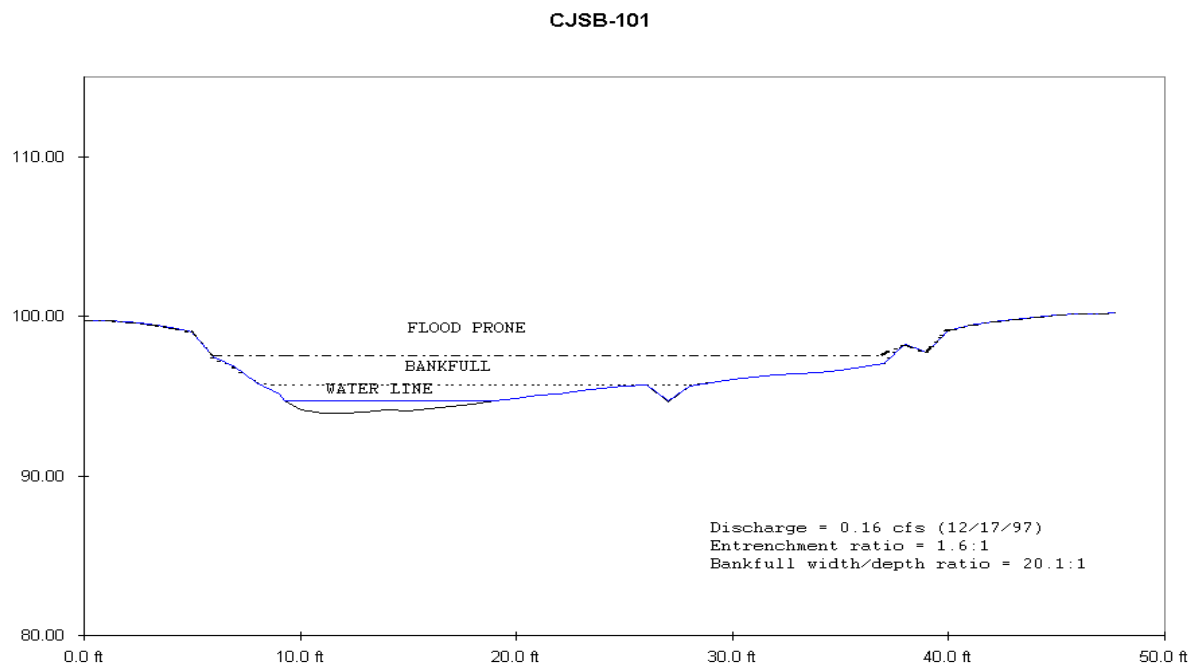
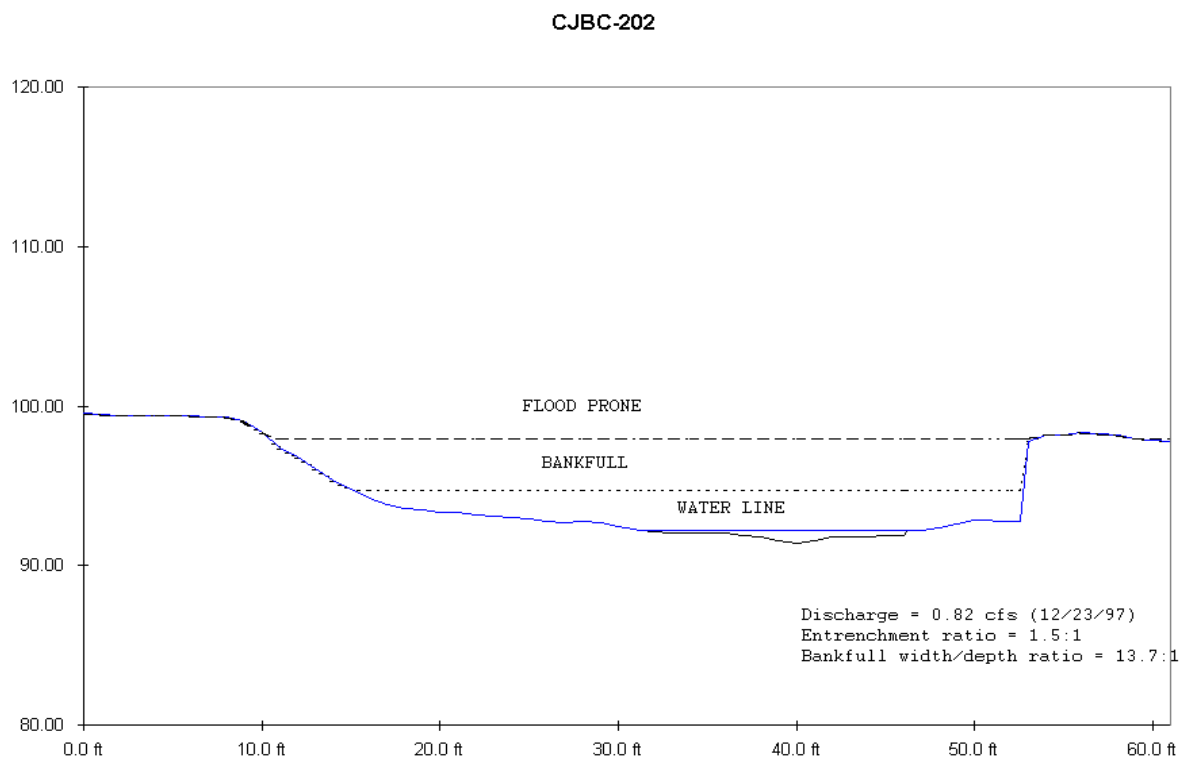
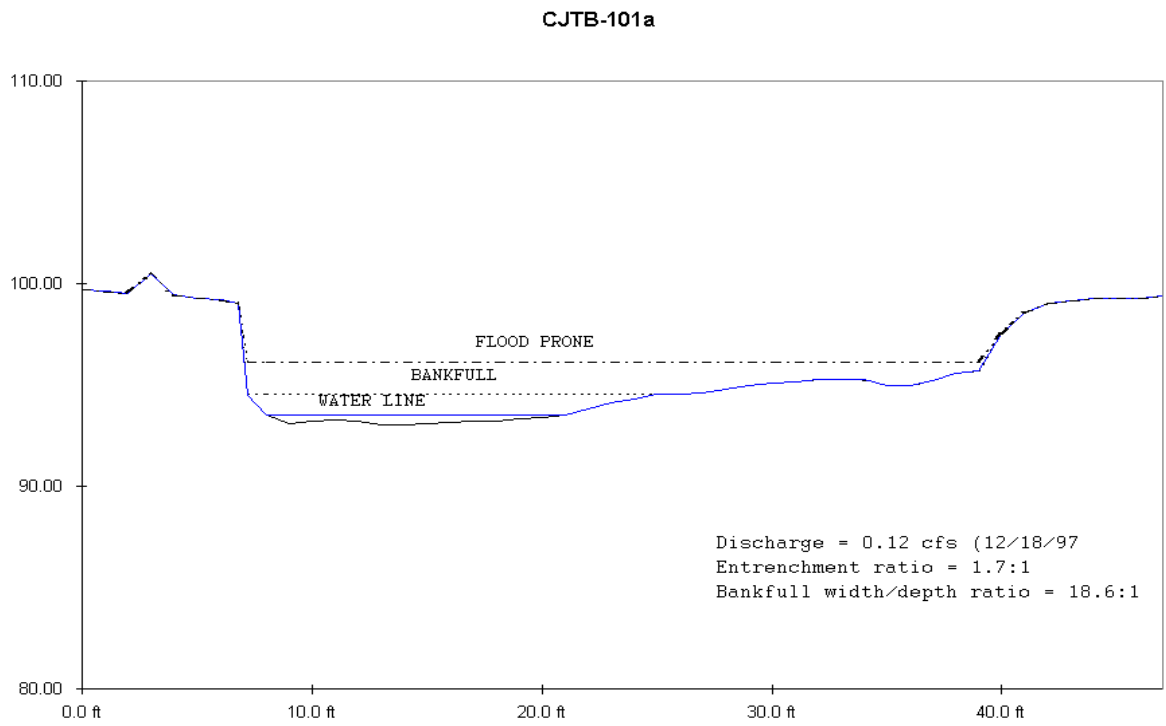
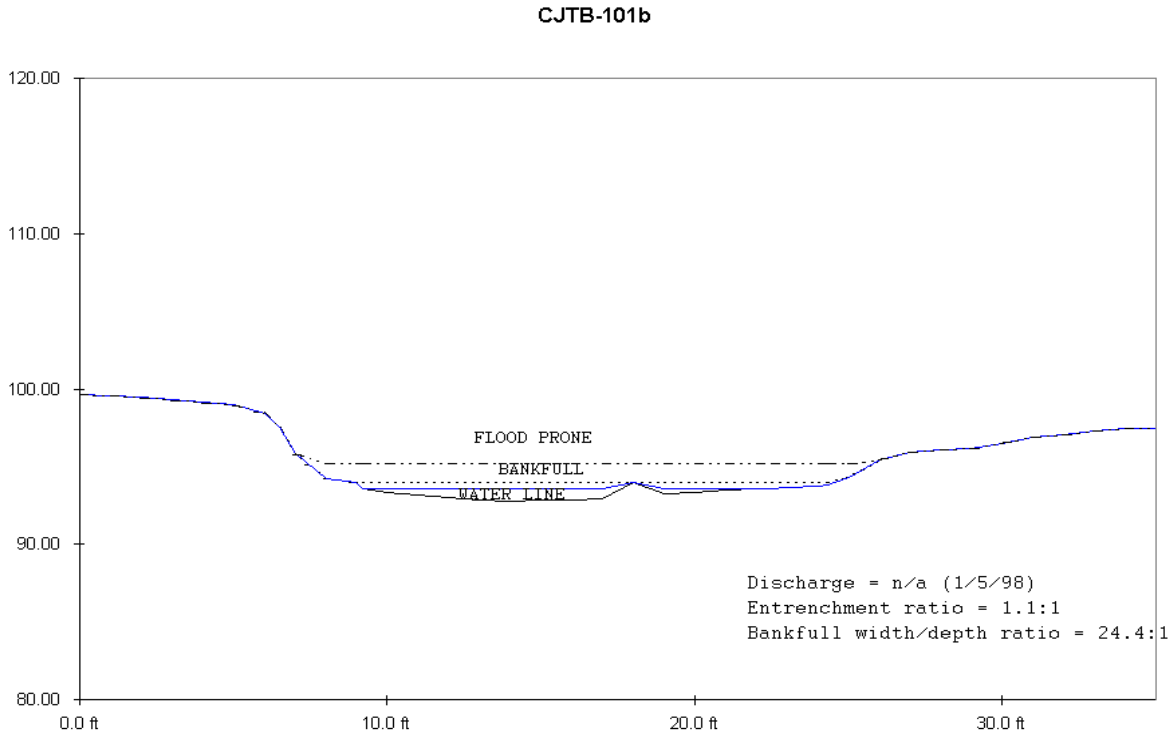
Figure 11. Cross Sections at Snakeden Branch and Booze Creek Monitoring Stations, 1996.

Cross section analysis of the Snakeden Branch (CJSB101), Booze Creek (CJBC202) (Figure 11), and Thomas Branch (CJTB101a) and (CJTB101b) tributaries (Figure 12) also indicate incised channels in these tributaries. Entrenchment ratios ranged from 1.1-1.7 at these stations indicating severely entrenched stream channels. Bankfull width depth ratios ranged from 14:1 to 24:1 indicating overly widened stream channels.

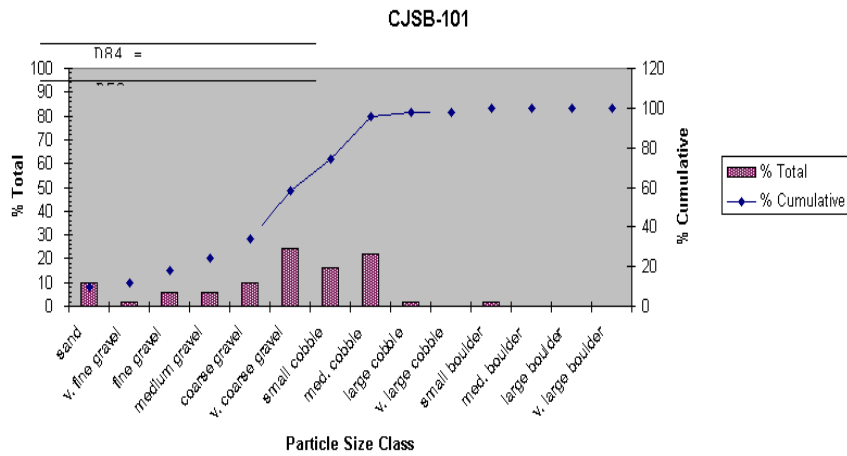
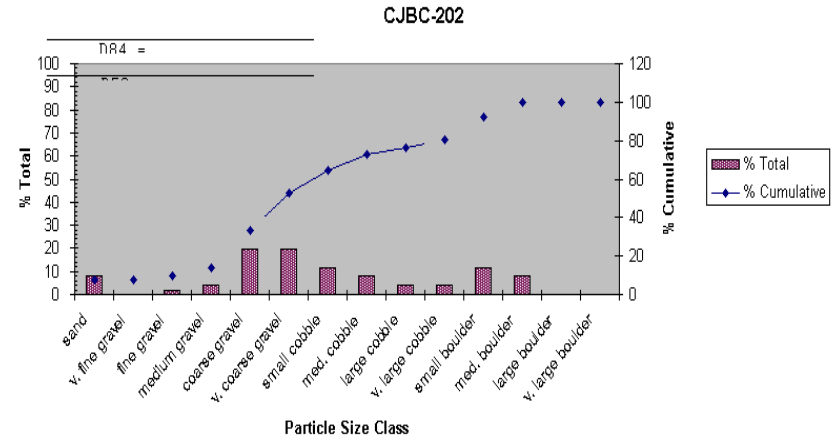
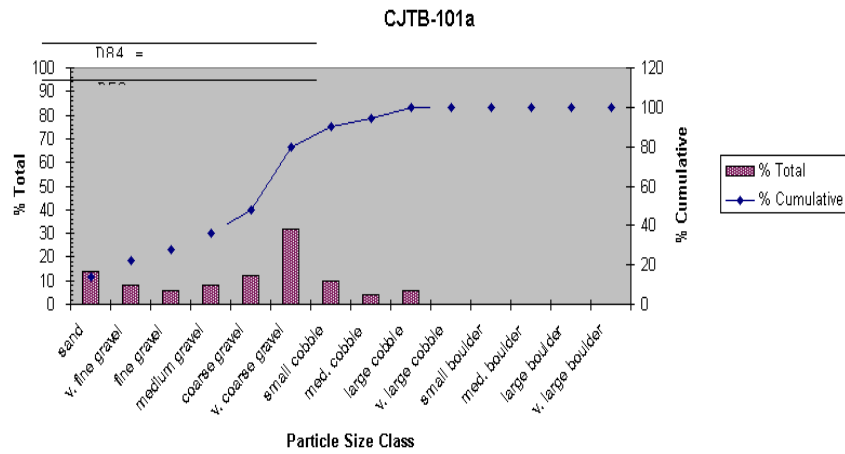
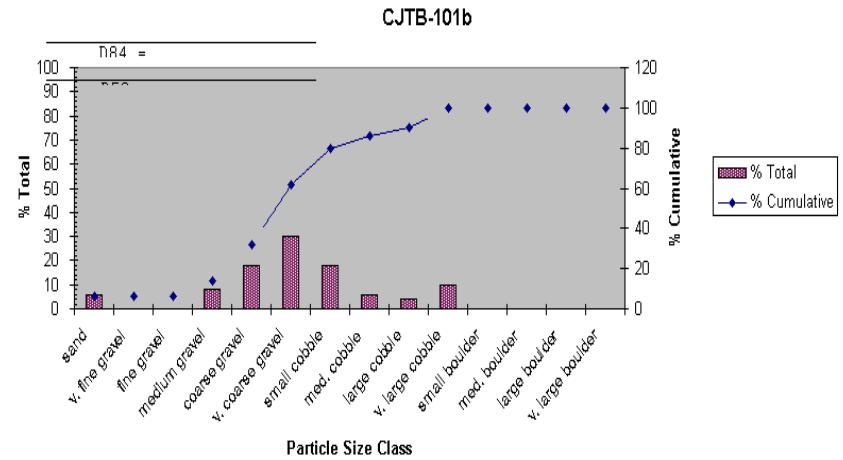
Figure 13. Riffle Particle Size Distribution for Snakeden Branch, Booze Creek, and Thomas Branch Monitoring Stations, 1996.

Pebble counts ranged from a D_{50} of coarse gravel to very coarse gravel (Figure 13). Habitat for benthos would be expected to be slightly limited in this particle size substrate.

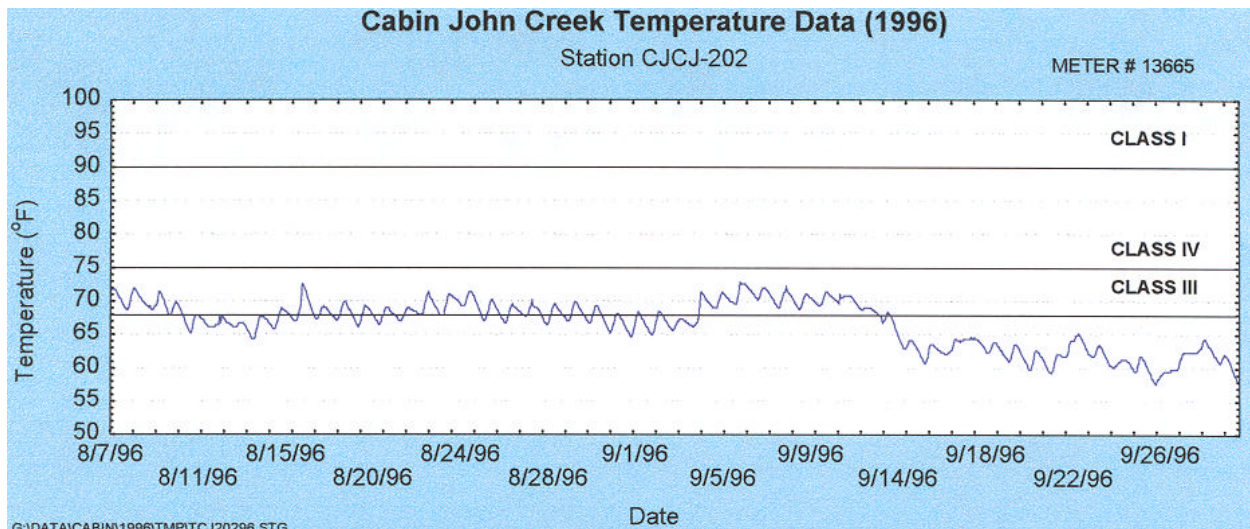
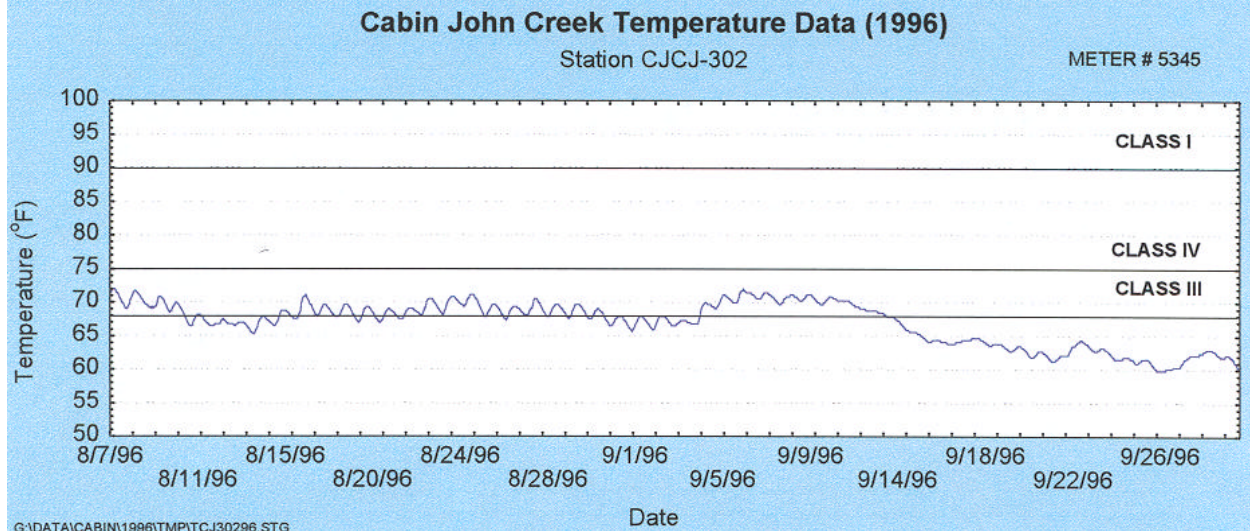
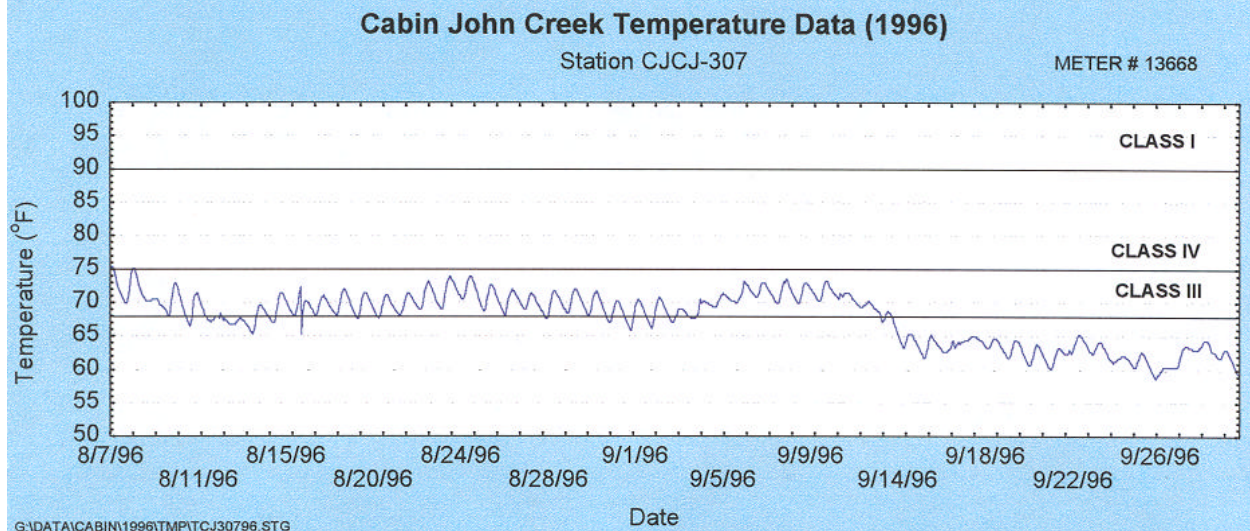
**Figure 14. Cabin John Creek Water Temperatures
for August to September, 1996.**

Three continually recording temperature meters were placed in the Cabin John Creek mainstem during August through September 1996. Temperature meters were distributed at stations CJCJ202, CJCJ302, and CJCJ307. All stations from the top to bottom of the watershed exhibited temperatures well within the State of Maryland's Use classification standard for Class I streams (Figure 14 (90° F)). Although Cabin John is not classified a class IV put-and-take trout stream by the state, the temperatures also did not exceed the Use IV temperature criteria (75° F) during this time period.
